9th International Conference „Bridges in Danube Basin 2016“, BDB 2016

Four historical steel bridges over the Mureş River

Abstract

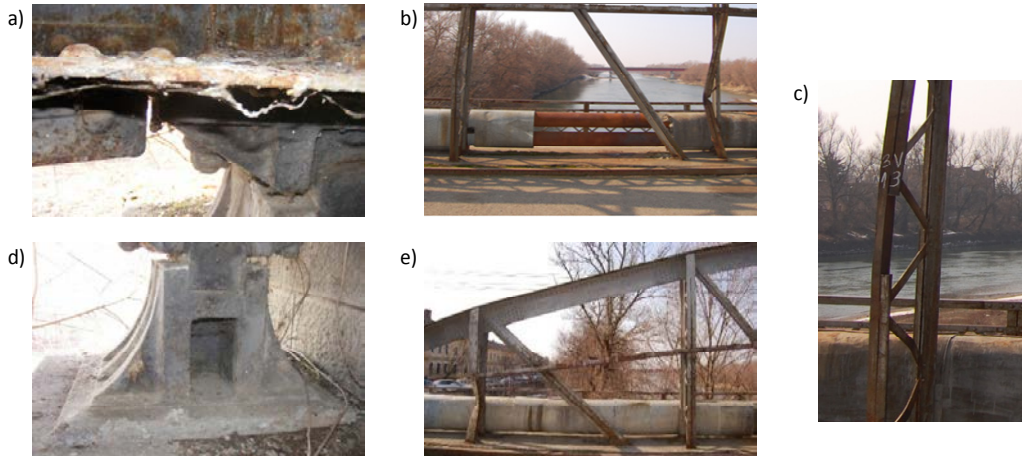
Due to the complete lack of maintenance, the bridge has many defects:

- Corrosion (Fig. 8a);
- Sectioned and deformed posts (Fig. 8b);
- Damaged elements due to the impact with vehicles (Fig. 8c);
- Jammed bearings (Fig. 8d);
- Old pipeline out of service with an unaesthetic aspect (Fig. 8e).

Fig. 8. Defects of the Bridge in Lipova: (a) corrosion; (b) damaged post; (c) sectioned and deformed post; (d) jammed bearings; (e) old pipeline out of service with unaesthetic aspects.

In 1996 a new bridge was erected in the neighborhood of the old bridge. Consequently, the structure was transformed in a pedestrian bridge. The proposal is to transform the bridge in an emblematic place in the old center of the town. In this direction the following operation are proposed:

- completely removing of the pavement;
- sand blasting;
- necessary repairs – on the base of a project;
- new function: touristic info point, happenings spot. The bridge connects two main objectives (the old fortress -in rehabilitation- and the Franciscan Monastery - also in rehabilitation), with the old city center;
- painting of the structure;

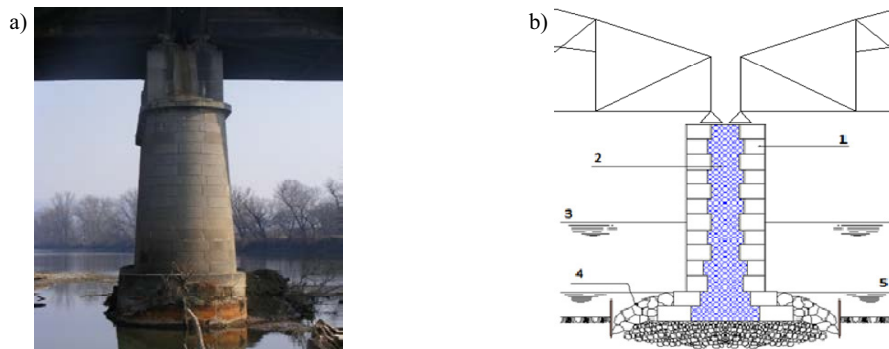
During some repair works of the new parallel concrete bridge, the “light” traffic was diverted on the old steel bridge (Fig. 12b). Generally, the behaviour of the foundations is satisfactory. Only some reparations are necessary together with the regulation of the river bed (Fig. 13a).

Fig. 13. (a) piers of the bridge in Lipova; (b) the foundation of the bridge: 1 – natural stone, 2 – cyclopean.

Similar to other already investigated structures, the foundation is a direct one (Fig. 13b). It was executed in dry conditions at a low water level.

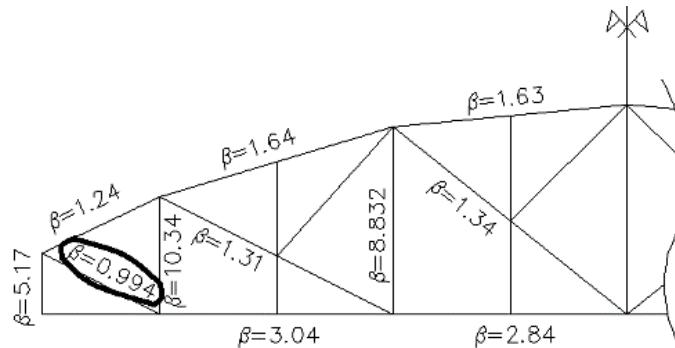
Fig. 15. Values of β (Ilia)

By taking into consideration all investigated cases it has been concluded that accumulated damage in the case of this structure is satisfactory, in conclusion the bridge can be strengthen.

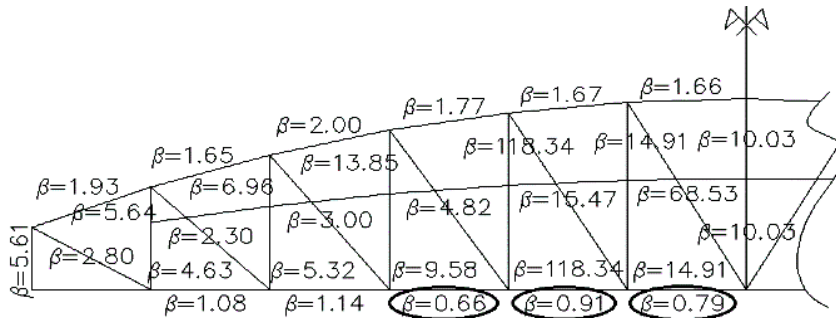
Fig. 167. Values of β (Lipova)

It can be seen, that for the bridge in Lipova, the stresses in some elements are higher than the allowable ones. The cause is the concrete deck with $h=50$ cm provided in the early '60 during the strengthening of the structure.
